Manhole Inspection Summary

Manhole # S25KK1022MH

Location Address: **4400 EVANS CHAPEL RD**

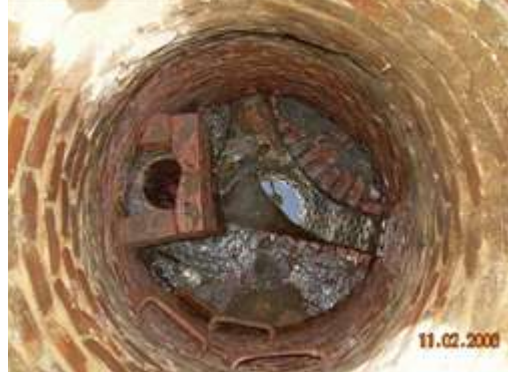
Top View

☒ **Debris** (not Condition related)

Missing: **1**

☒ **Corroded**

☒ **Evidence Of Surcharge**

Corroded and missing steps. Evidence of surcharge - Bench debris. Channel debris

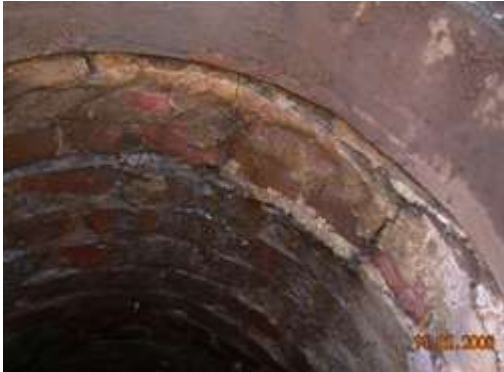
Defect

☒ **Leaks**

Condition: ☐ Sound ☐ Cracked ☐ Root Intrusion ☐ Loose Brick ☒ **Deteriorated**

Infiltration: ☐ None ☒ **Joint** ☐ Cracks ☒ **Mortar** ☐ Roots ☐ Wall

Frame leaks. Adjustment deterioration and infiltration.

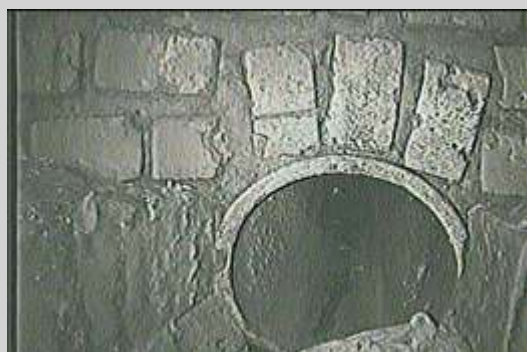
Pipe Out @ 12 O'Clock

Deposits: ☐ None ☐ Mud ☐ Sludge ☒ **Debris** ☐ Grease

Silt Depth: **0** (in.) Deposits Extent: **Light**

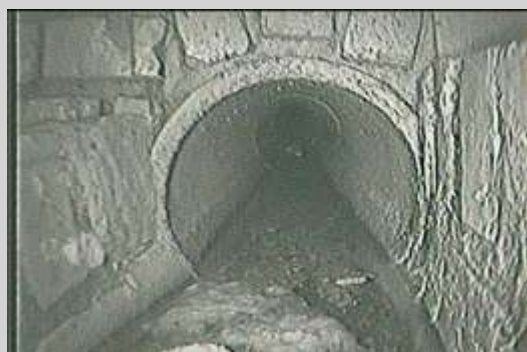
Pipe In @ 4 O'Clock

Deposits: ☐ None ☒ **Mud** ☐ Sludge ☒ **Debris** ☐ Grease

Silt Depth: **0.5** (in.) Deposits Extent: **Light**
